# Transmission Main Condition Assessment: Manito & 57<sup>th</sup>

Manito Transmission Main 1.1 Miles of 24" Steel Main 57<sup>th</sup> Avenue Transmission Main 2.0 Miles of 18"/24"/30" Steel Main

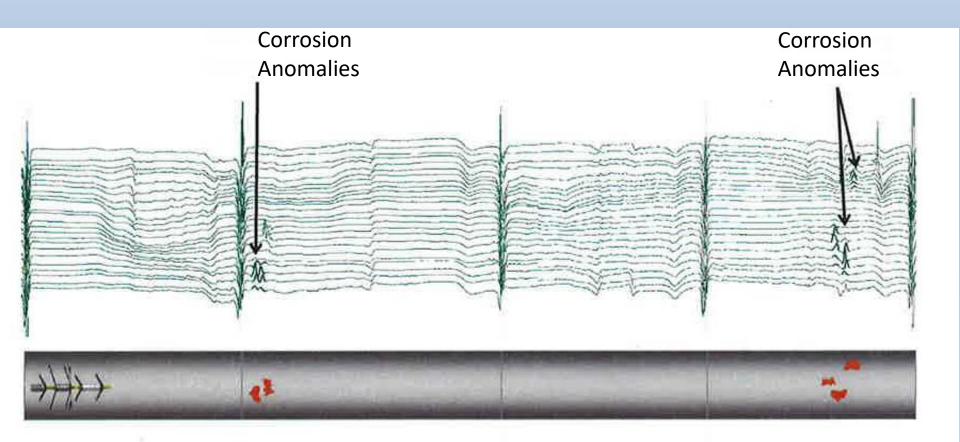
## Electromagnetic Inspection Data Analysis

| Table 1: Electromagnetic Anomalies in 57th Avenue Transmission Main | | | | | |
| 11 | 48+77 | 7 | 297 | 4 | 20% |
| 1172 | 80+71 | 2 | 351 | 4 | 35% |
| | | 3 | 351 | 3 | 45% |
| 1174 | 81+51 | 25 | 260 | 5 | 50% |
| | | 27 | 305 | 4 | 50% |
| | | 28.5 | 110 | 3 | 35% |

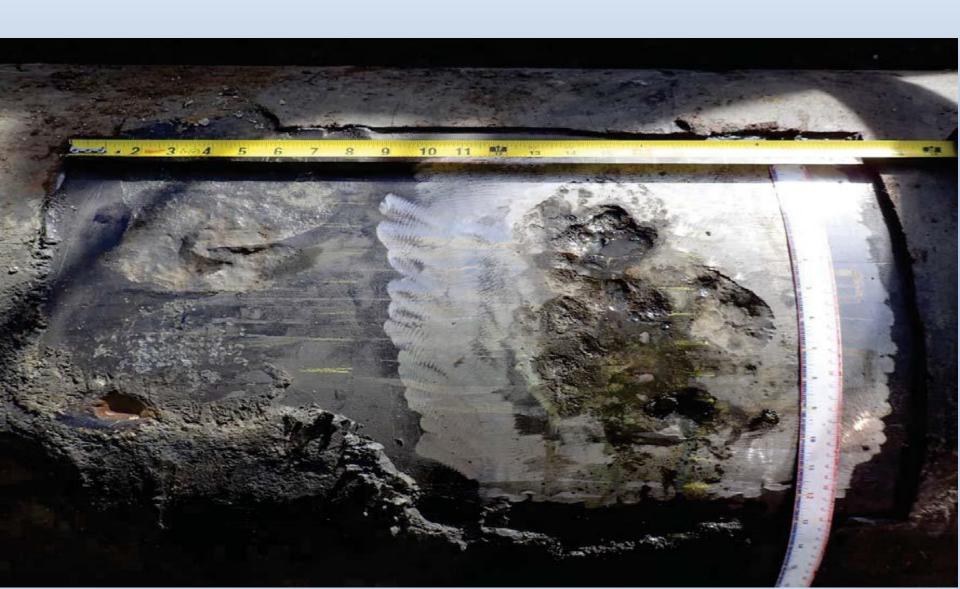
### Leak Detected 57th & Palouse

- 282 pipe segments inspected
- 1 leak detected
- 3 Pipe segments with electromagnetic Anomalies
