Transmission Main Condition Assessment: Manito & 57th

Inspection Results

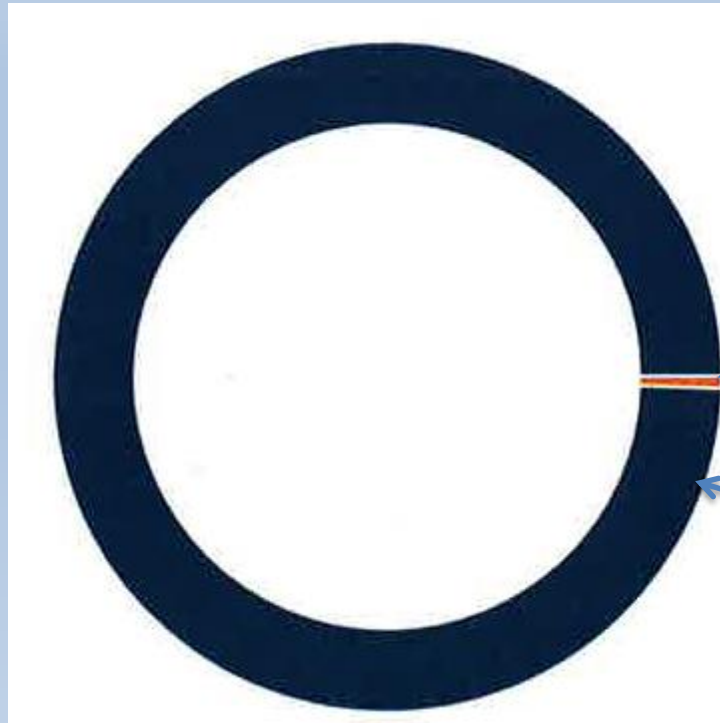
- ❖ 282 pipe segments inspected
- ❖ 1 leak detected
- ❖ 3 Pipe segments with electromagnetic Anomalies

0.6% of pipes with corrosion

99.4% of pipes with no corrosion

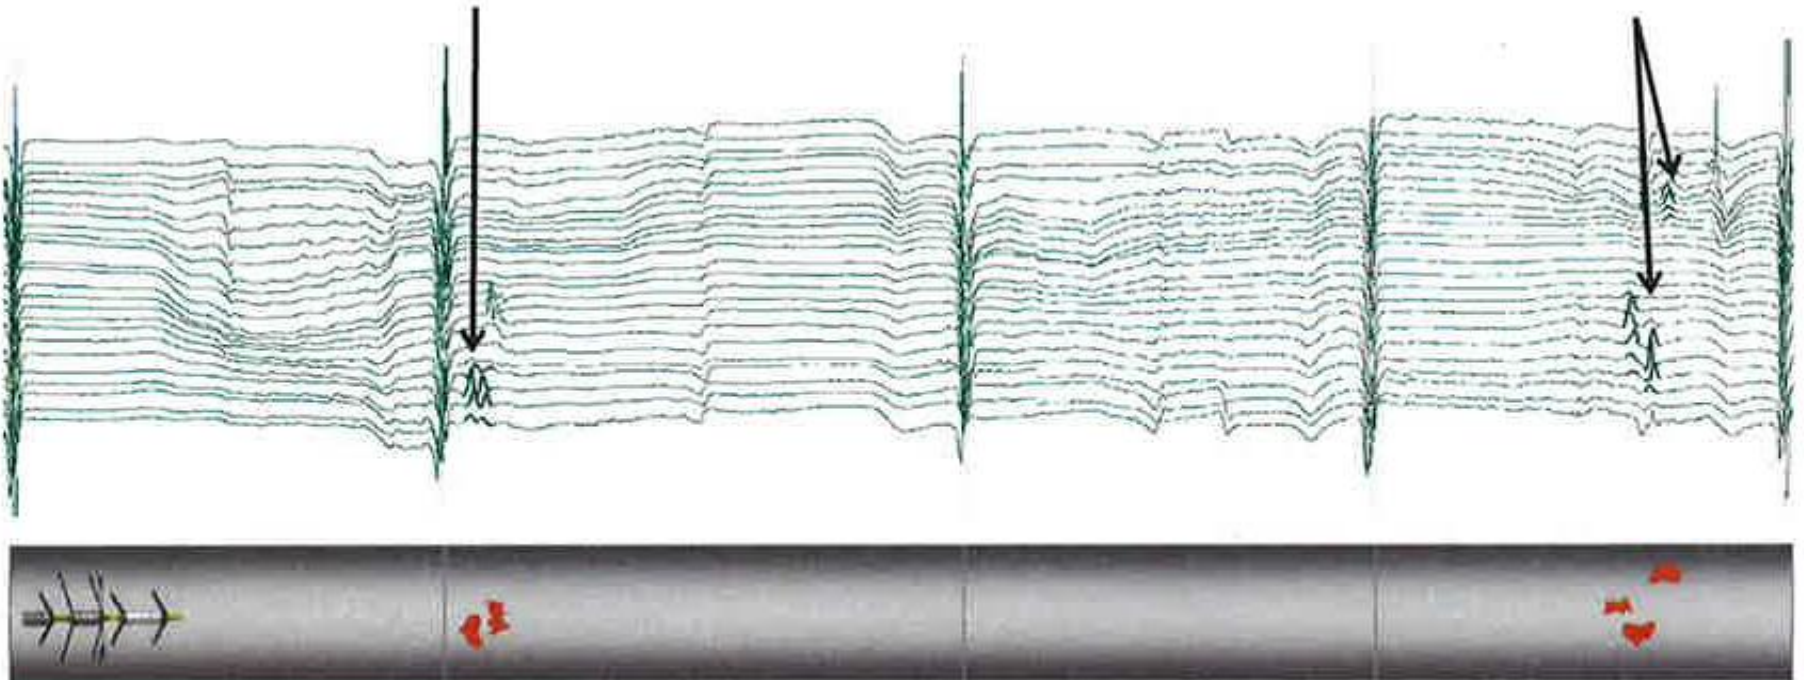
Table 1: Electromagnetic Anomalies in 57th Avenue Transmission Main

Corrosion
Anomalies

Pure Reference Number	Upstream Joint (Station)	Longitudinal Position of Anomaly (feet from Upstream joint)	Circumferential Position of Anomaly (degrees facing Downstream)	Calculated Volume Loss (cubic inches)	Estimated Depth of Wall Loss
11	48+77	7	297	4	20%
1172	80+71	2	351	4	35%
		3	351	3	45%
1174	81+51	25	260	5	50%
		27	305	4	50%
		28.5	110	3	35%

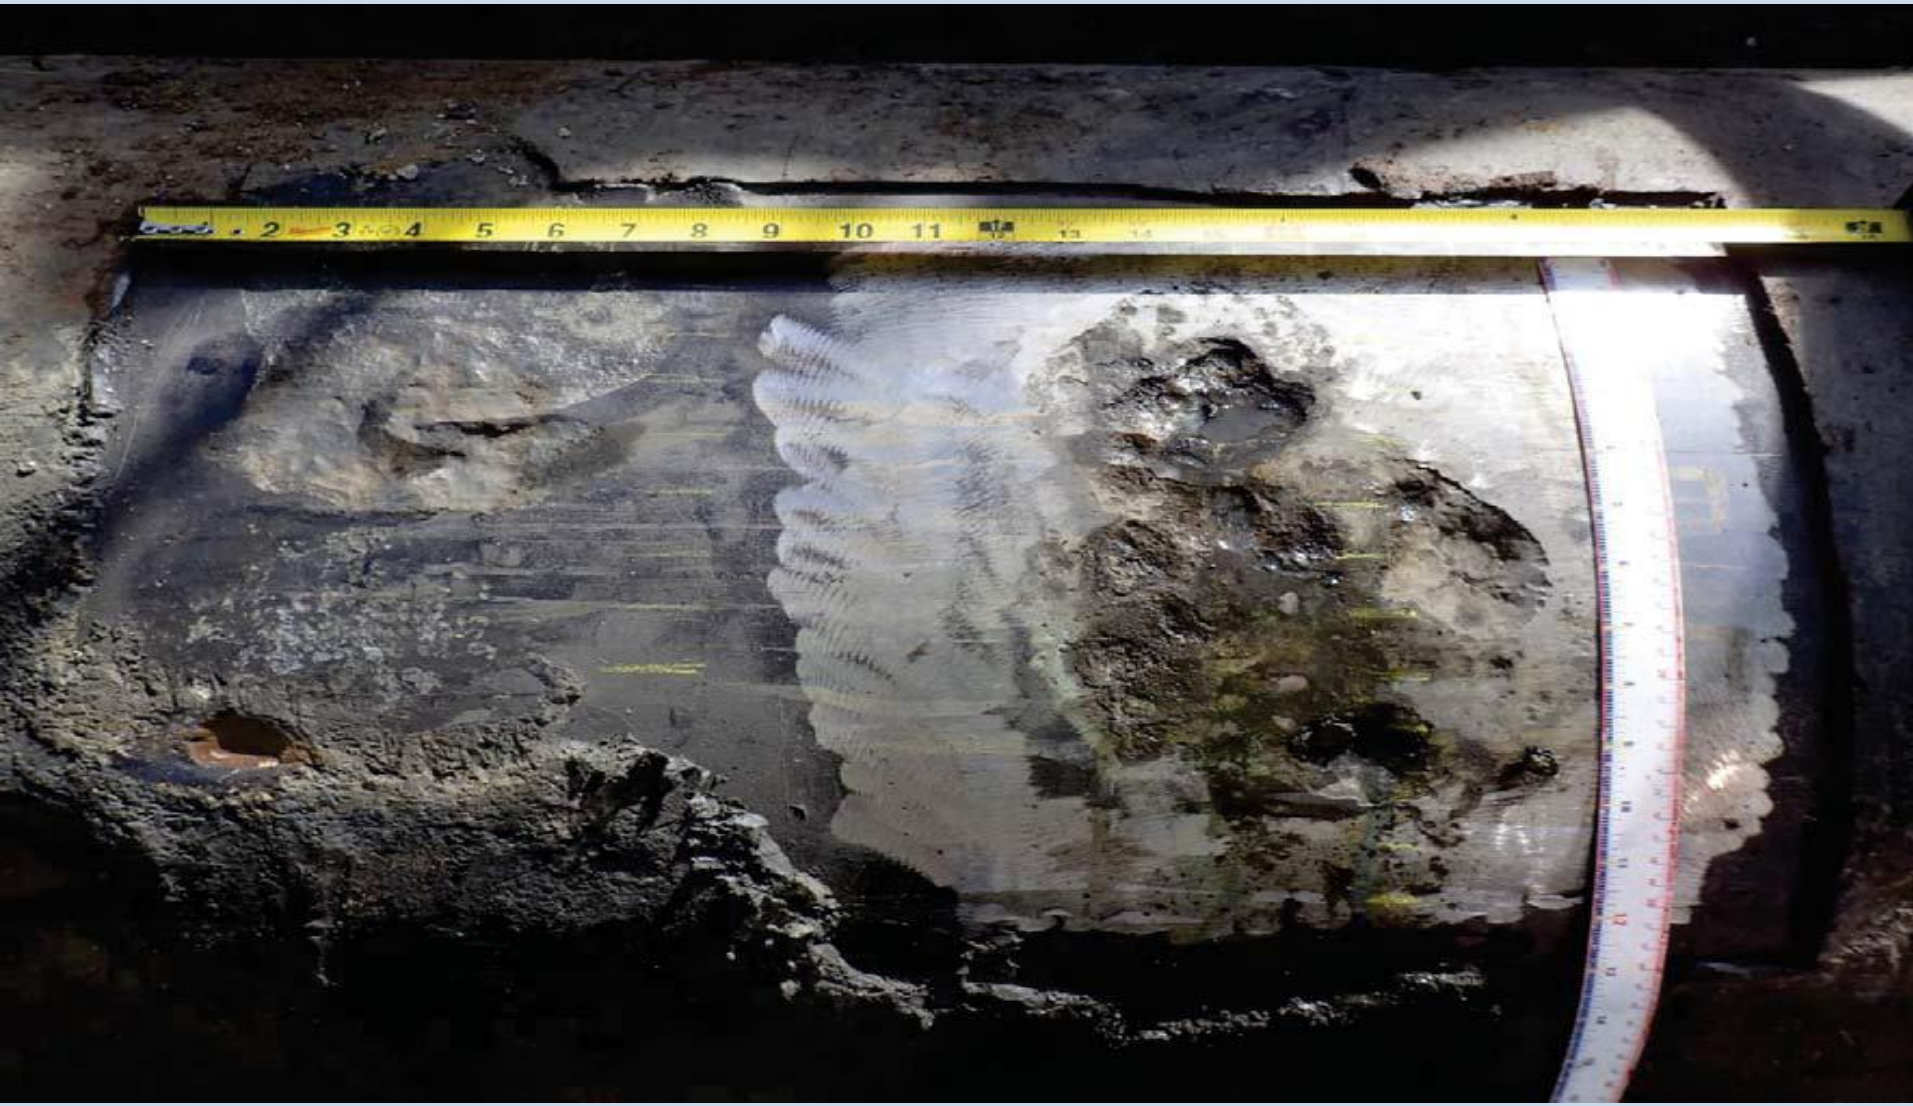
Leak Detected 57th & Palouse
