# Transmission Main Condition Assessment: Manito & 57<sup>th</sup>

Manito Transmission Main 1.1 Miles of 24" Steel Main 57<sup>th</sup> Avenue Transmission Main 2.0 Miles of 18"/24"/30" Steel Main

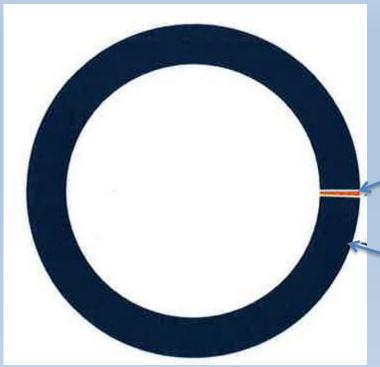
#### **Manito Transmission Main**

- 202 pipe segments inspected
- Zero leaks
- Zero electromagnetic anomalies

0.6% of pipes with corrosion

99.4% of pipes with no corrosion

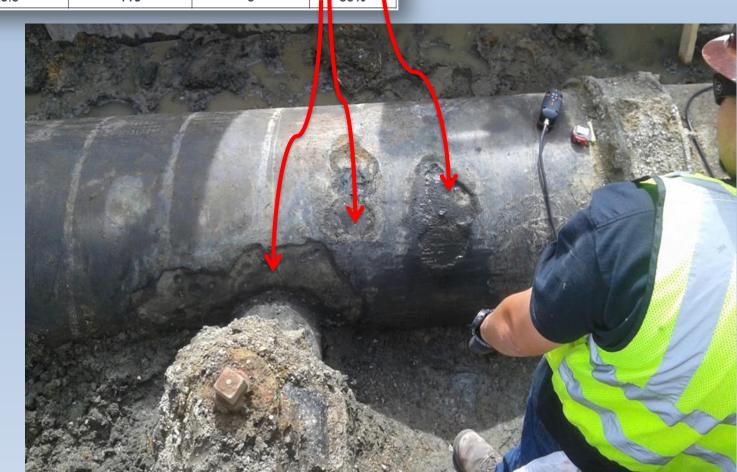
| Table 1: Electromagnetic Anomalies in 57th Avenue Transmission Main | | | | | |
| Pure<br>Reference<br>Number | Upstream<br>Joint<br>(Station) | Longitudinal Position of Anomaly (feet from Upstream joint) | Circumferential Position of Anomaly (degrees facing Downstream) | Calculated<br>Volume Loss<br>(cubic inches) | Estimated<br>Depth of<br>Wall Loss |
| 11 | 48+77 | 7 | 297 | 4 | 20% |
| 1172 | 80+71 | 2 | 351 | 4 | 35% |
| | | 3 | 351 | 3 | 45% |
| 1174 | 81+51 | 25 | 260 | 5 | 50% |
| | | 27 | 305 | 4 | 50% |
| | | 28.5 | 110 | 3 | 35% |
